# Big Willow Creek Water Quality Monitoring Report April 2007 through October 2007

Kirk Campbell  
Idaho State Department of Agriculture

ISDA Technical Report Summary W-24

March 2008

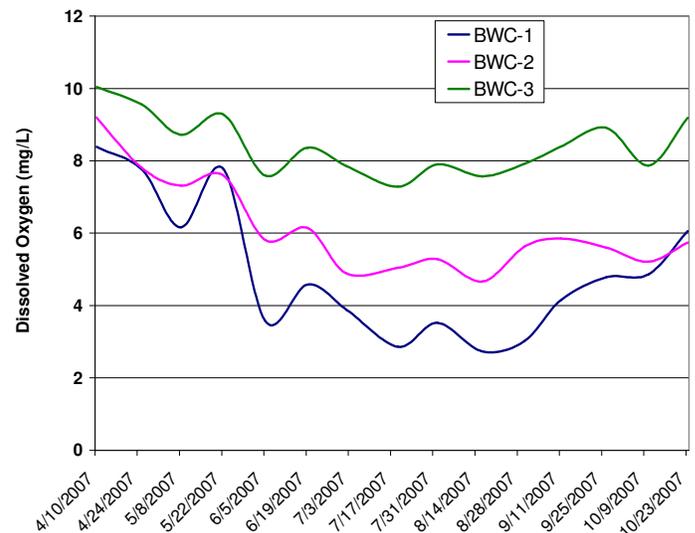
**Figure 3.** Dissolved Oxygen levels.

The two lower stations (BWC-1 and BWC-2) on Big Willow Creek showed depressed dissolved oxygen (DO) levels starting in early June through October (Figure 3). The state of Idaho water quality standards require systems designated as cold water biota maintain a DO level of 6.0 mg/L or higher.

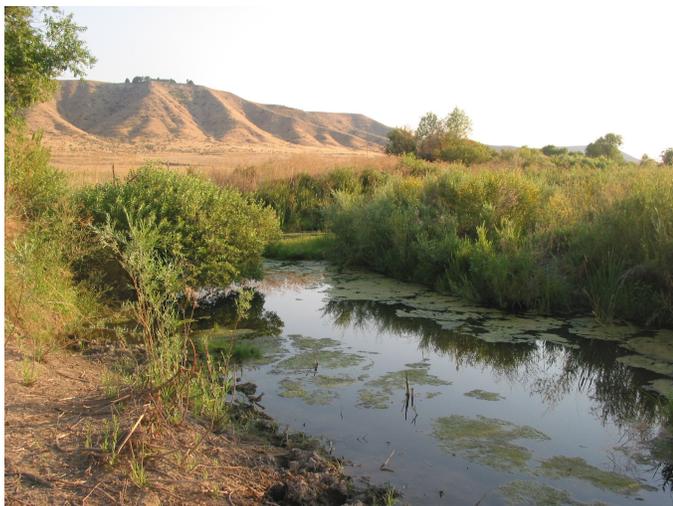
Another potential cause of low DO could be the excessive algal and aquatic vegetation growth that occurs at both of the lower stations (Figure 5). This excessive growth may be a direct result of the high dissolved phosphorus concentrations along with low discharge and warm water temperatures.

**Figure 5.** Site BWC-1 with excessive aquatic vegetation.

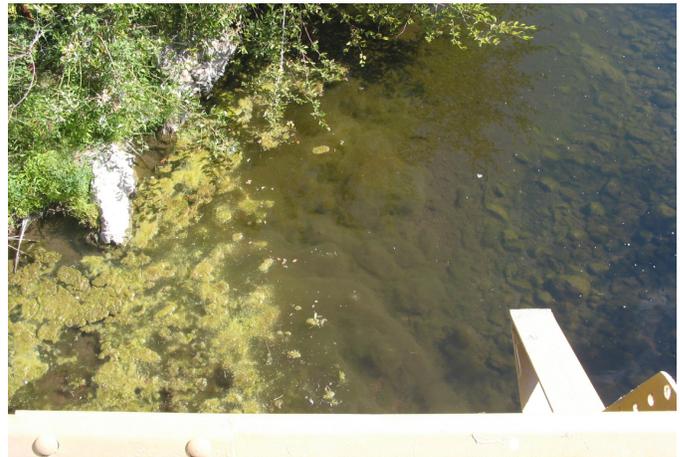
The large algae blooms that plague Big Willow Creek can be viewed in Figure 6 which is at Succor Creek road bridge just upstream of BWC-2 sampling site.

**Figure 6.** Algae blooms at station BWC-2
